# Bushfire Burnover Assessment of NanoChar™ Coated Powers Poles May 2013

CSIRO Ecosystem Sciences  
EP135714  
May 2013  
Commercial in Confidence

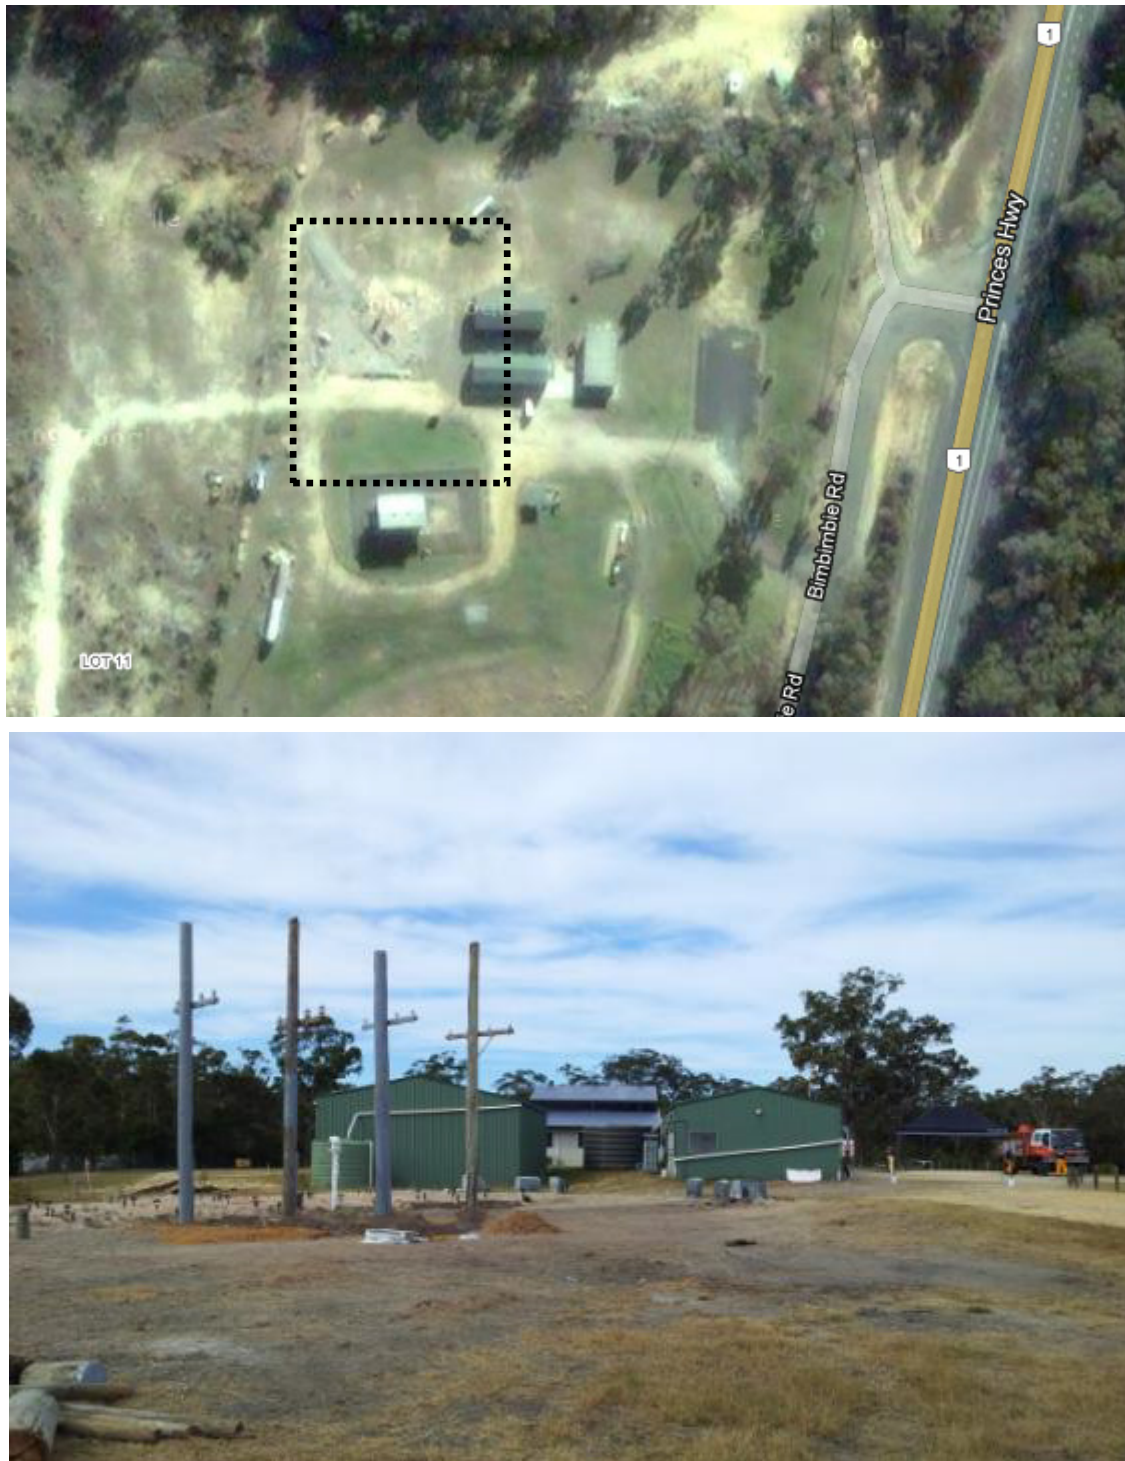
Figure 1 CSIRO's bushfire flame front simulator at the NSW Rural Fire Service Eurobodalla Training Centre at Mogo NSW.

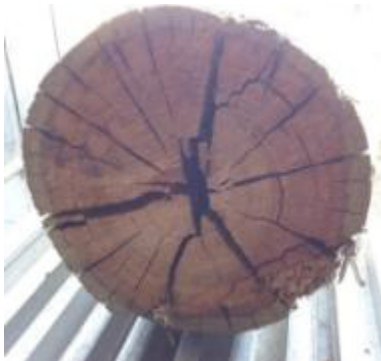
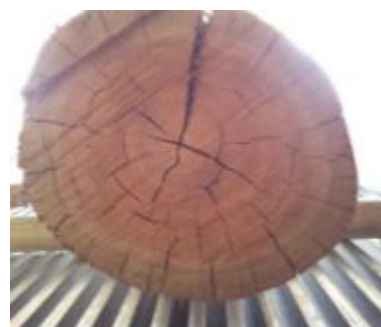
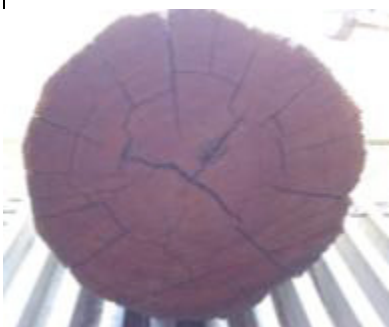
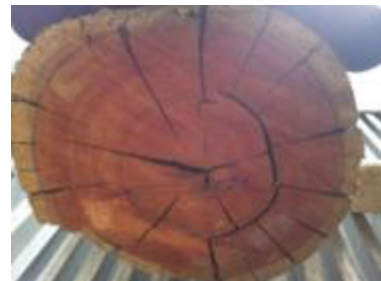
Table 1 Timber description

Pole	Surface	Timber	End Section
1 Treated	CCA Treated Sapwood	Spotted Gum  Hardwood with CCA Treated Sapwood

2 Coated 1	NanoChar™ Coated over CCA Treated Sapwood	Spotted Gum  Hardwood with CCA Treated Sapwood

3 Untreated	Heartwood	Blood Wood  Hardwood supplied without sapwood

4 Coated 2	NanoChar™ Coating over CCA Treated Sapwood	Iron Bark  Hardwood with CCA Treated Sapwood

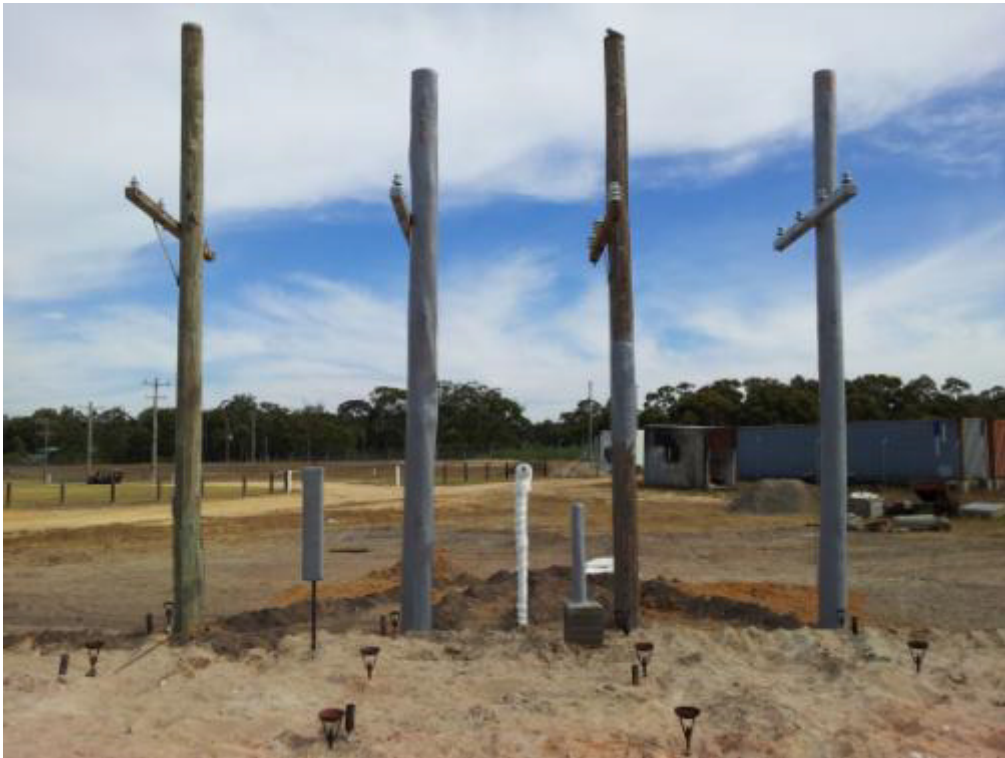
Figure 2 Poles as installed

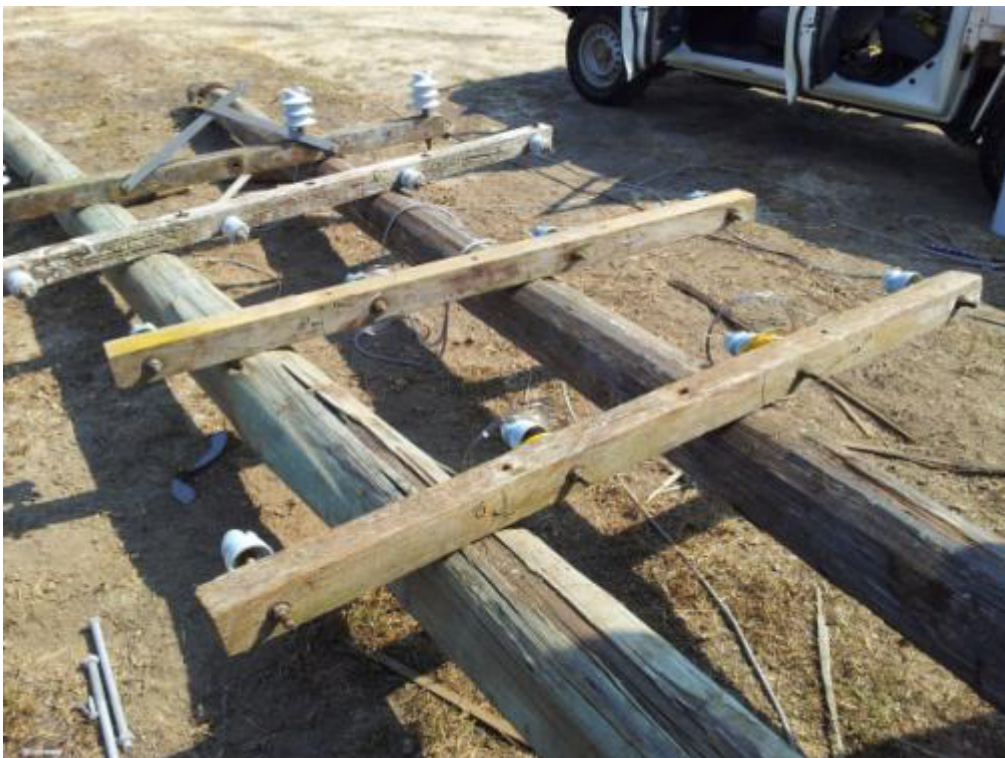
Figure 3 Cross bars

Each pole was installed with a hardwood cross-arm that had been in use for some time so that the surface was weathered. The cross-arms installed on the coated poles were also coated. The cross-arms used are shown in Figure 3. In this figure the cross-arms (from top to bottom) were matched to the following poles 2, 1, 4 and 3 given in Table 1.

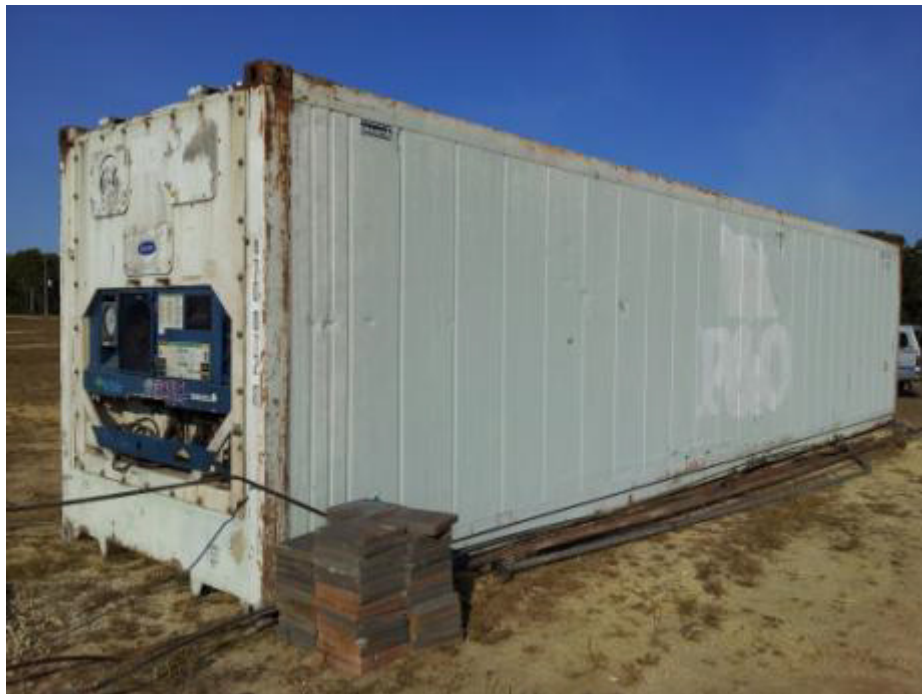
Figure 4 Insulated Container used for conditioning poles and cross-arms

The poles as supplied were already in a seasoned condition as they had been in service. However, prior to installation the poles and the cross-arms were conditioned in a heated shipping container (see Figure 4 & 5) for one week at  $>40^{\circ}\text{C}$  to reduce any surface moisture content. A check of the moisture content using a moisture meter showed the timber to be in a well seasoned state. To control the moisture content the uncoated poles were wrapped in plastic after conditioning and installation (see Figure 6). This was removed just prior to testing. Samples were taken from the power prior to testing and assessed for their moisture content using a gravimetric method. Samples were between 12-12.7% Moisture Content. Note: Lower moisture content levels may be reached in actual worst case bushfire conditions, these lower moisture contents are likely to have caused more extensive combustion of the unprotected poles but are not likely to significantly influence the coated pole performance.

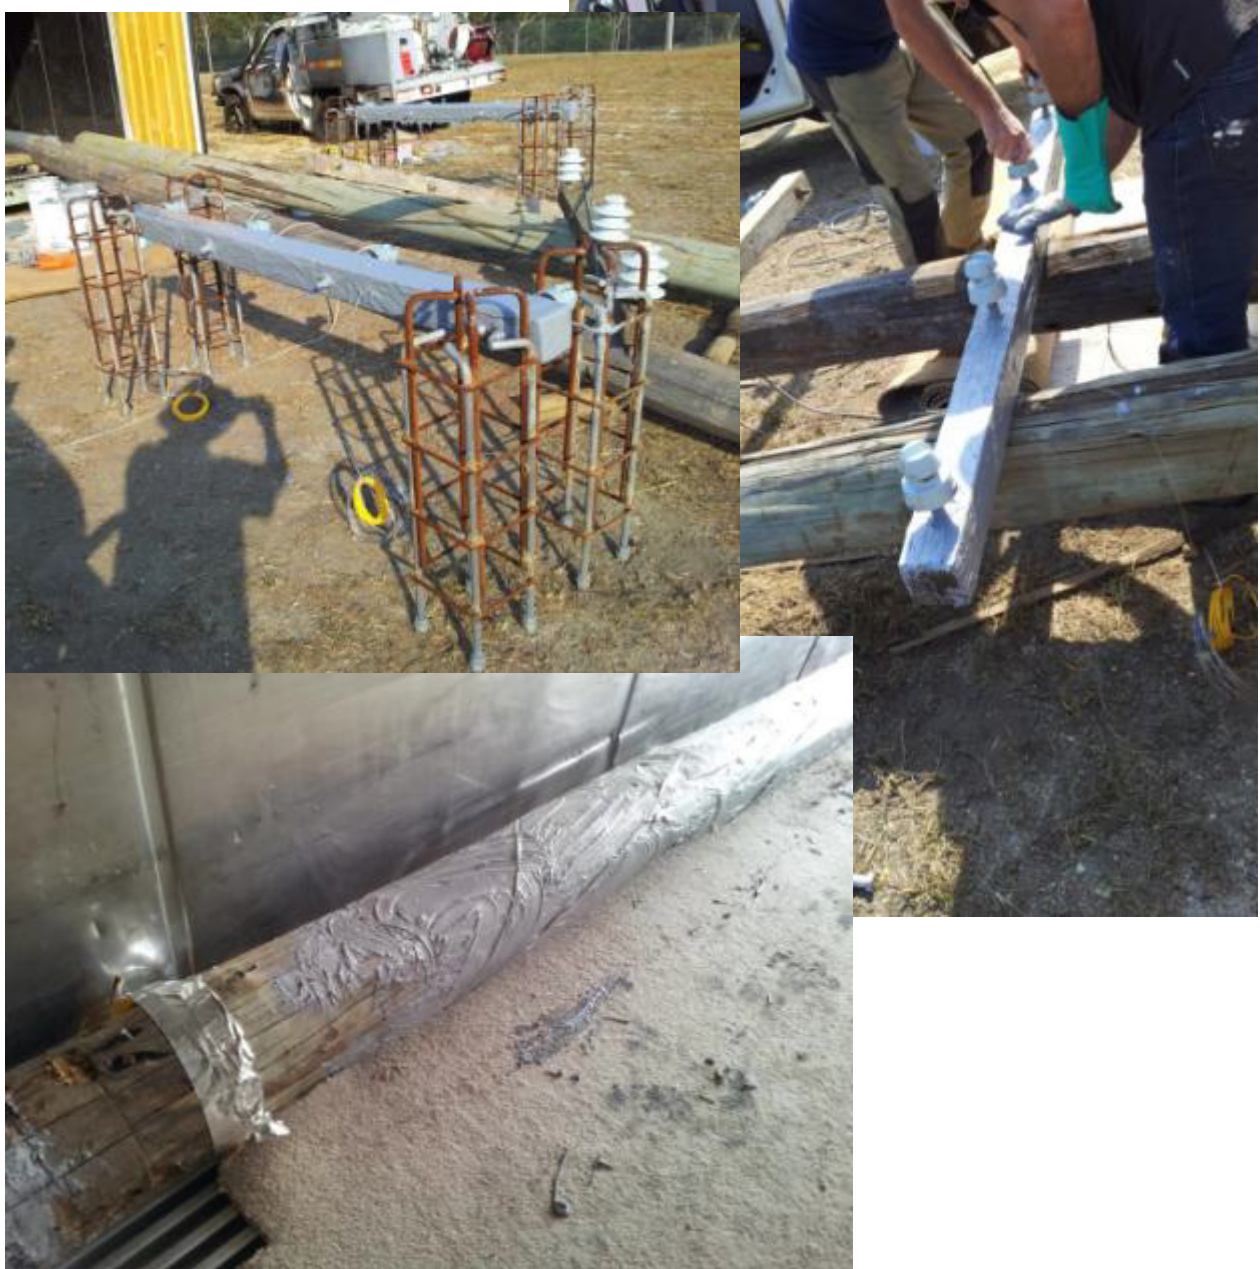
Figure 7 Application of coating

The coating was applied by Pilbara Insulation two days prior to positioning the poles on the test pad. This was to allow enough time for the coating to cure. The application of the coating is shown in Figure 7.

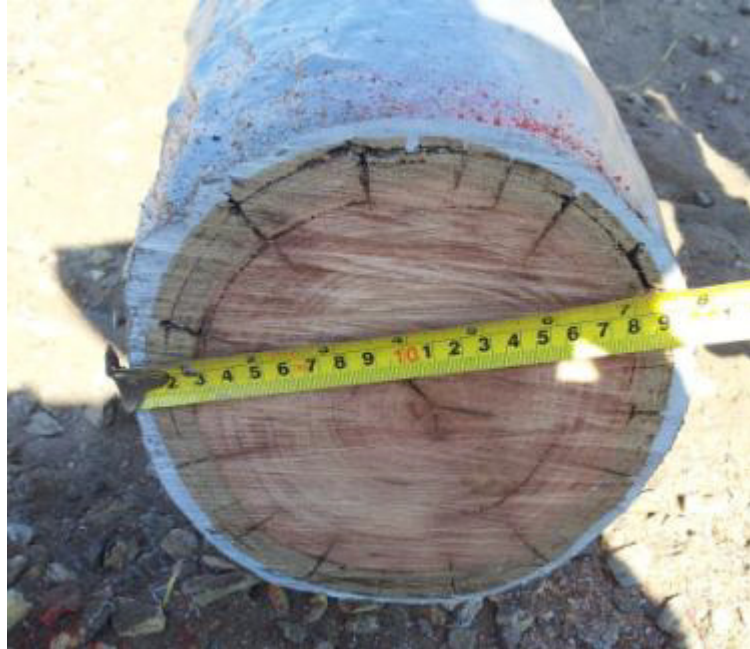
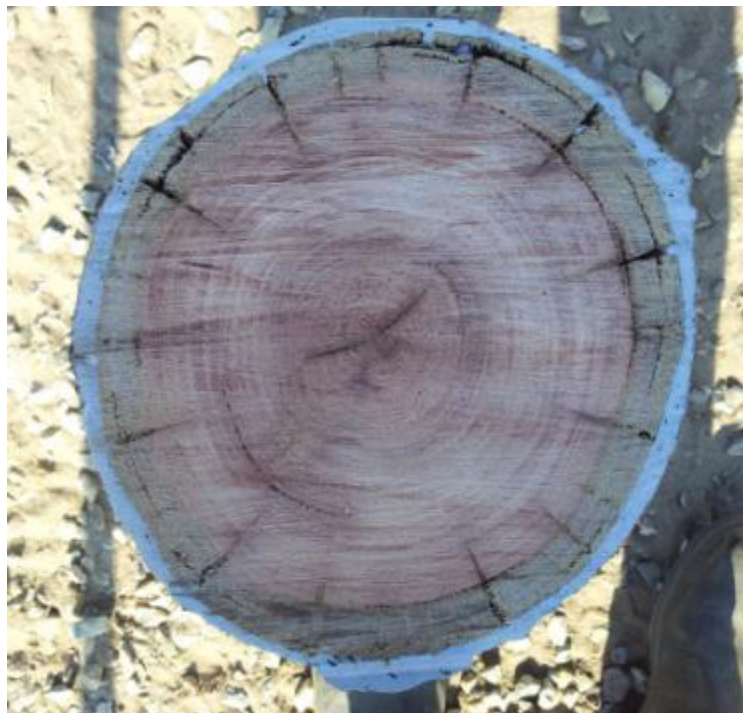
Figure 8 Coating thickness

The thickness of the coating varied between 4-10mm with an average of approximately 6-7mm (see Figure 8). In commercial application the coating would be more uniform and applied with a target thickness of 4-6mm.

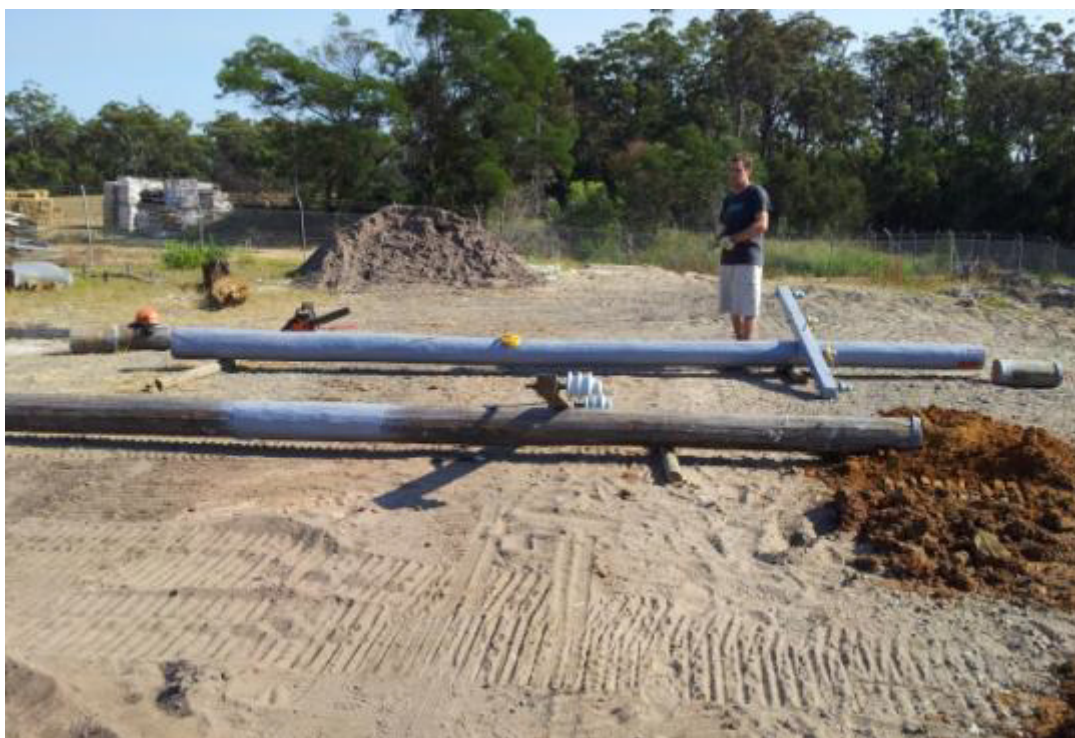
Figure 9 Bare ends of poles removed

For ease of coating, the ends of the poles were left bare to allow the poles to be turned over. Prior to installation the ends were cut off (see Figure 9) and coating was applied to the top. The bottom was left uncoated as it was to be installed 1.4m into the ground. For comparison a 1 m section of the untreated pole (pole 3) was coated (see Figure 9) approximately 2 -3m above the installed ground level.

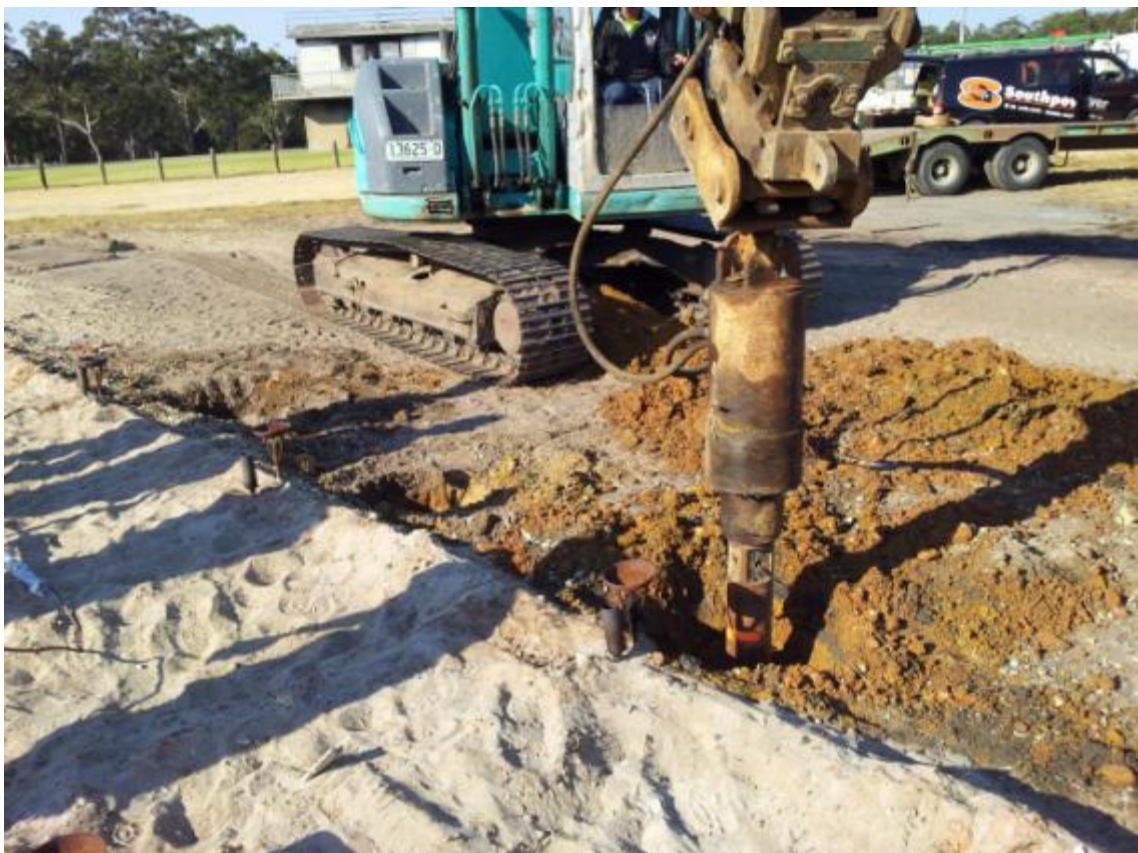
Figure 10 Boring of holes in test pad, each pole adjacent to a burner

The poles were installed to a depth of approximately 1.4m using a boring attachment to an excavator (see Figure 10). Each pole was located adjacent (~0.5m offset) to a grid burner (at 2m spacing) to provide uniform exposure. The installed poles are shown in Figure 2. The cross-arms were orientated as in use (perpendicular to the line of the poles).

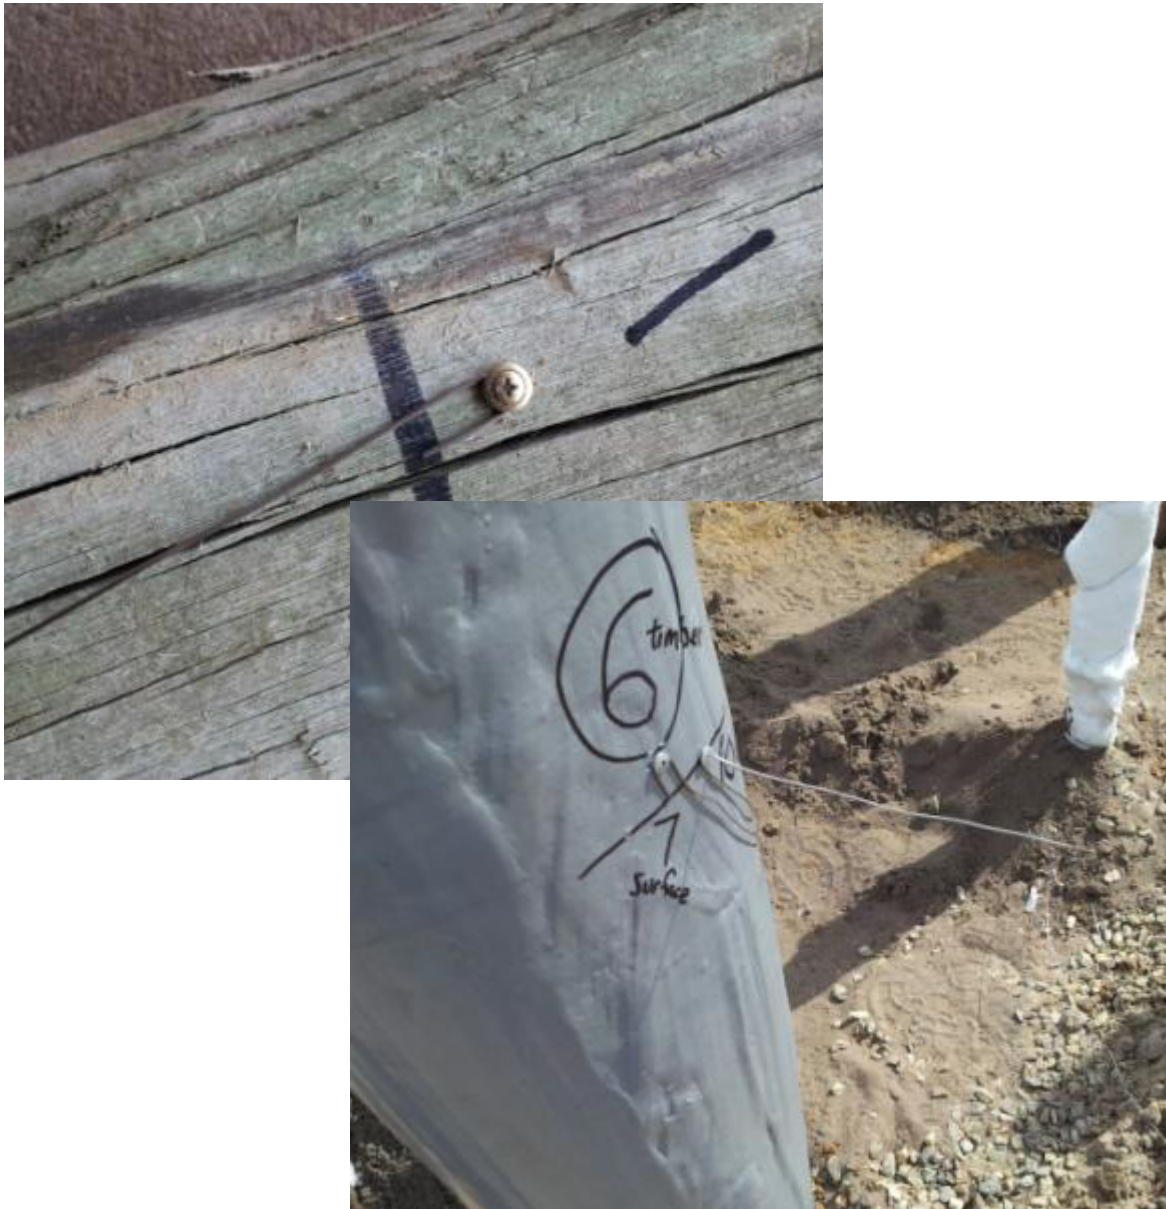
(top: thermocouple installed prior to coating, bottom: thermocouple installed to measure coating surface and air temperature)

Figure 12 Typical thermocouple installation

- they have been successfully used in previous tests
- along its length the probe is protected against the high temperatures (1050°C) that were likely to be experienced
- where surface temperature was required the thermocouple could be held by screws and bent to give a positive contact to the surface as shown in Figure 12.

On the coated poles, thermocouples were installed against the timber surface prior to coating to provide a temperature measurement under the coating. Thermocouples used to measure air temperature extend out from the surface by 150mm as shown in Figure 12.

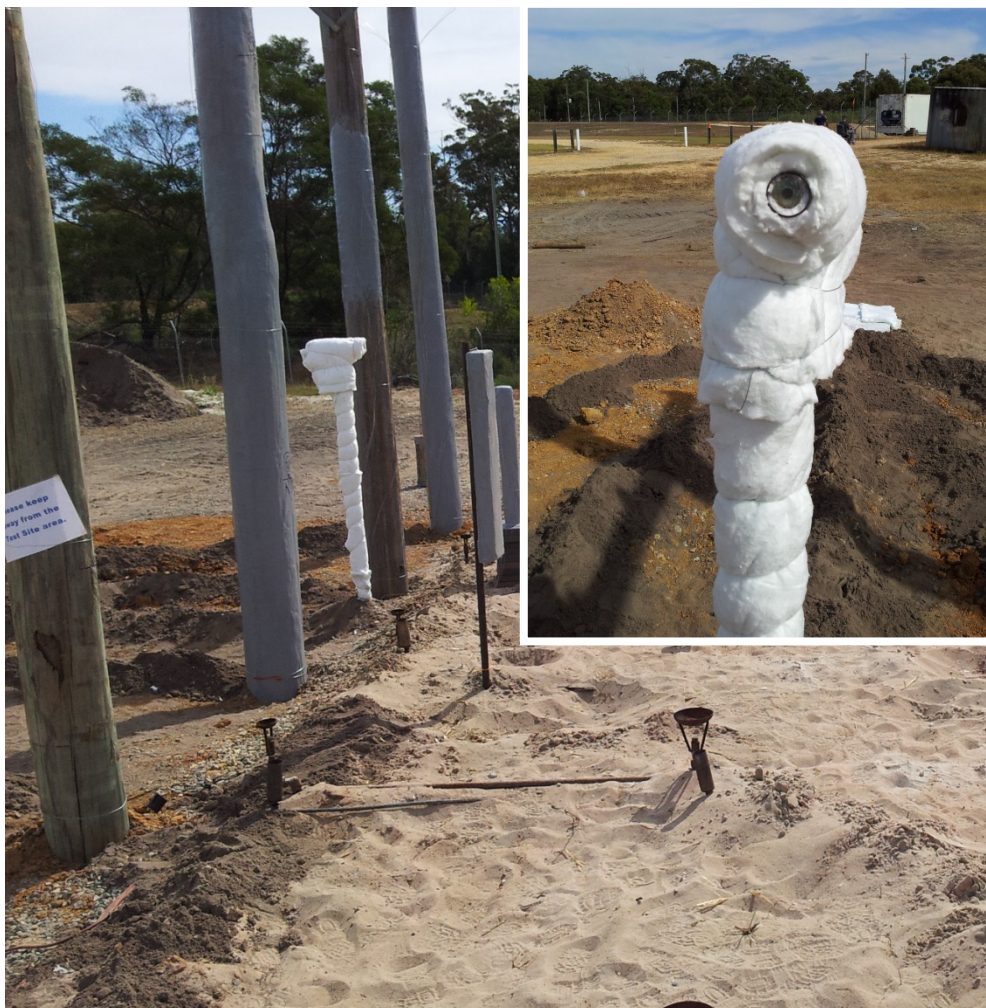
Figure 14 Radiometer wrapped in heat resistant blanket

A single radiometer (see Figure 14) was positioned at the centre of the poles between poles 2 and 3 to measure the applied radiant heat from the grid of gas burners. The details of the radiometer used are given below. This radiometer was constantly water cooled throughout the experiment.

Manufacturer:	Medtherm Corporation
Model No.:	64-10SB-18
Sensor Type:	Water cooled Schmidt-Boelter
Emissivity:	0.94
Range:	0 - 100 kW/m <sup>2</sup>

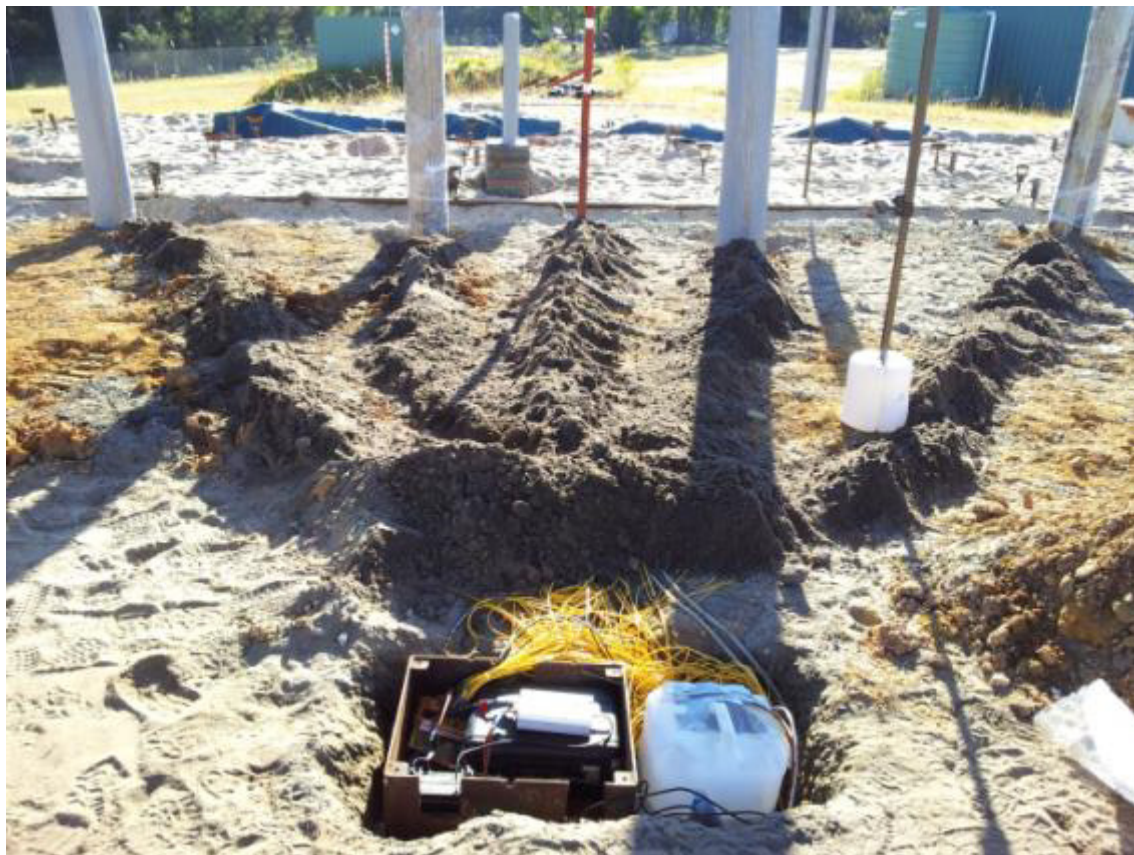
Figure 15 Instrumentation pit prior to being covered with insulation blanket and soil

The thermocouples and radiometer were logged at 5-second intervals via a Datataker 505 data logger with an expansion module. Wireless communications were used to transfer the data in real time back to a laptop in the control room. The data logger and wireless modem were placed in a pit in the ground and covered with insulation and soil. A 12V pump powered by a battery was used to circulate the water to the radiometers through silicone tubing from a container inside the pit (see Figure 15).

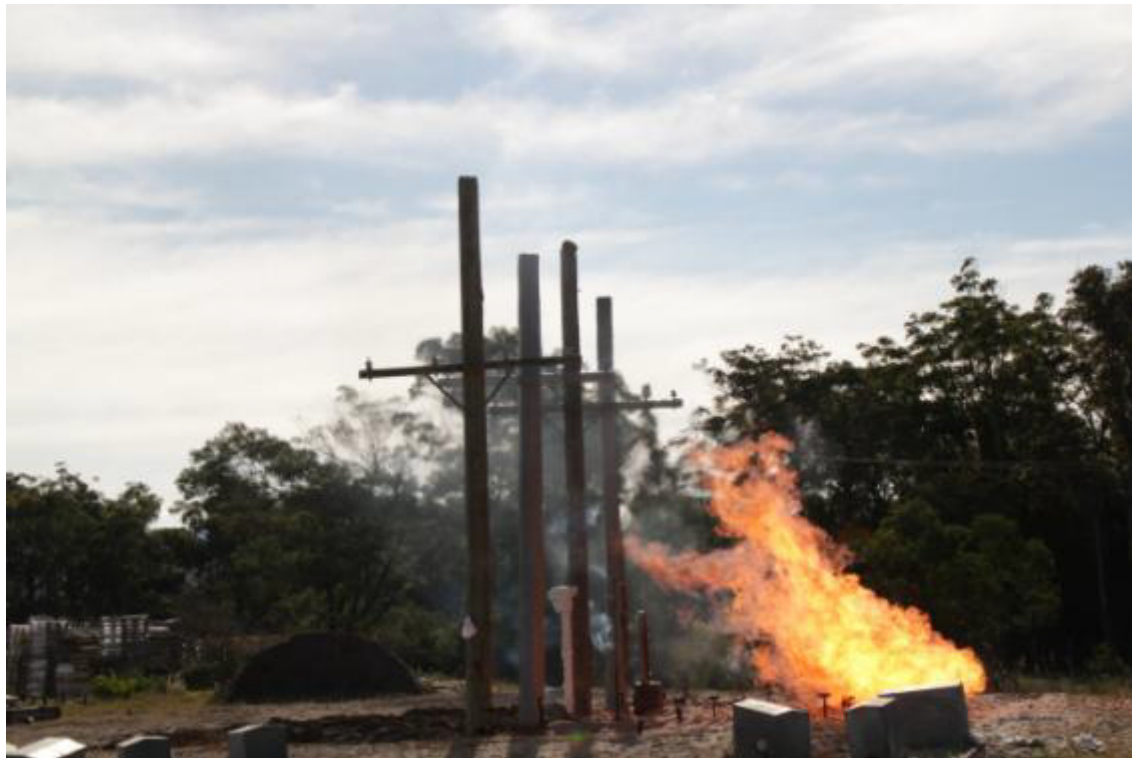
Figure 17 Poles during the radiant heat exposure phase

The pre and post fire front radiant heat is provided by a single row of burners set on the ground 5m from the front of the poles as shown in Figure 17. The timing of the test is matched to the weather conditions to ensure the heated air from the burners is blowing towards the poles.

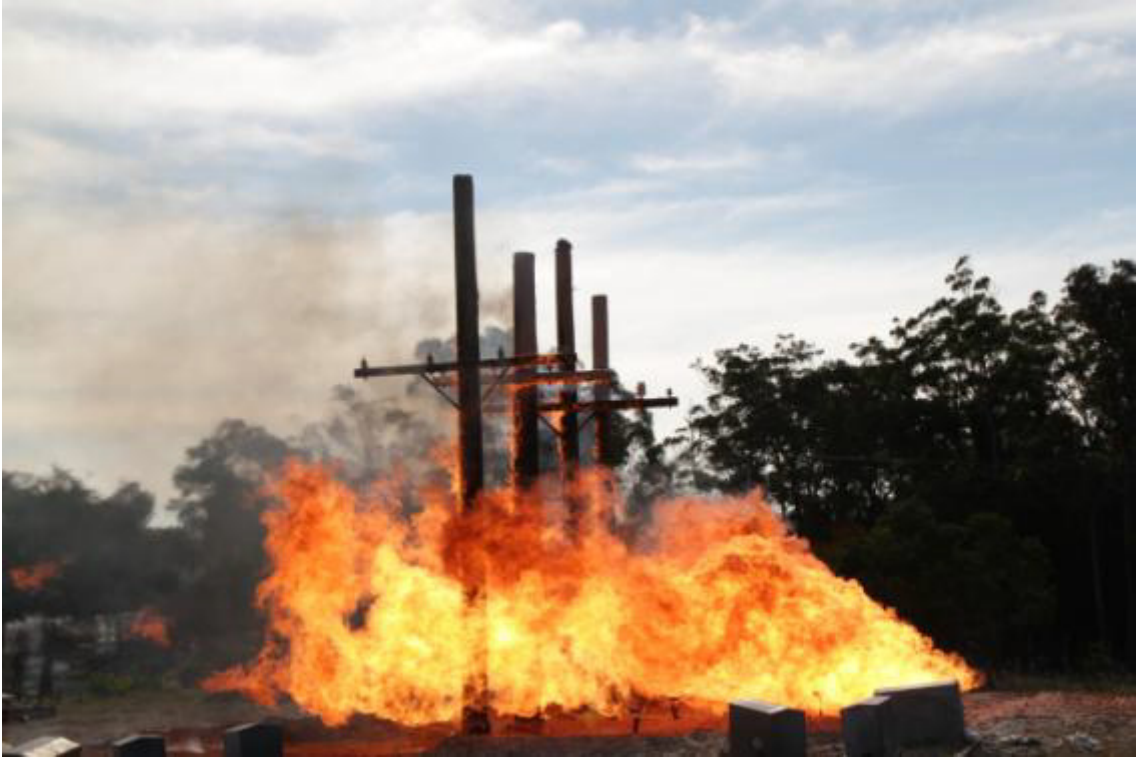
Figure 18 Poles during the flame immersion phase

The flame immersion stage uses a grid of burners immediately adjacent to the poles as shown in Figure 18. Following this phase there is a post flame front radiant heat phase using the same burners as the pre-fire front radiant heat phase as shown in Figure 19.

- *Flame Immersion.* At approximately 30 minutes into the test the flame immersion phase commences. This involves the activation of the main burners (shown in Figure 18). Six seconds before scheduled immersion, the dump valve is activated and main valve opened to allow rapid priming to burner jets. The dump valve is closed at the scheduled immersion time and, on visual confirmation of the main grid achieving full power, a secondary timer is started. Once the nominated duration of immersion is achieved on the secondary timer, a call is made to the simulator controller to reactivate the dump valve and close the main valve. At this stage the main grid is rapidly depowered. (The flame immersion for this test was scheduled to last 1.8 minutes.)

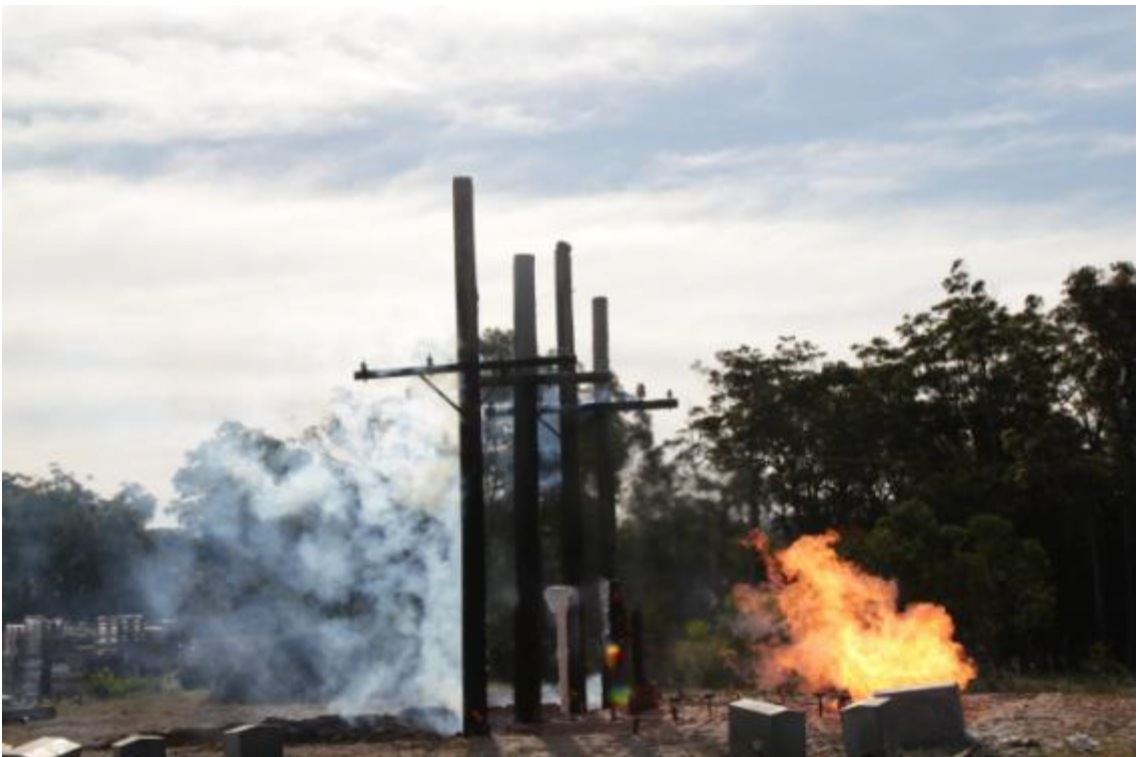
Figure 19 Post fire front radiant heat

- *Radiant Heat.* Once the flame immersion phase has finished the radiation burners are again used to provide the post-flame immersion radiant heat profile shown in Figure 19. Once this has been completed the grid is deactivated.

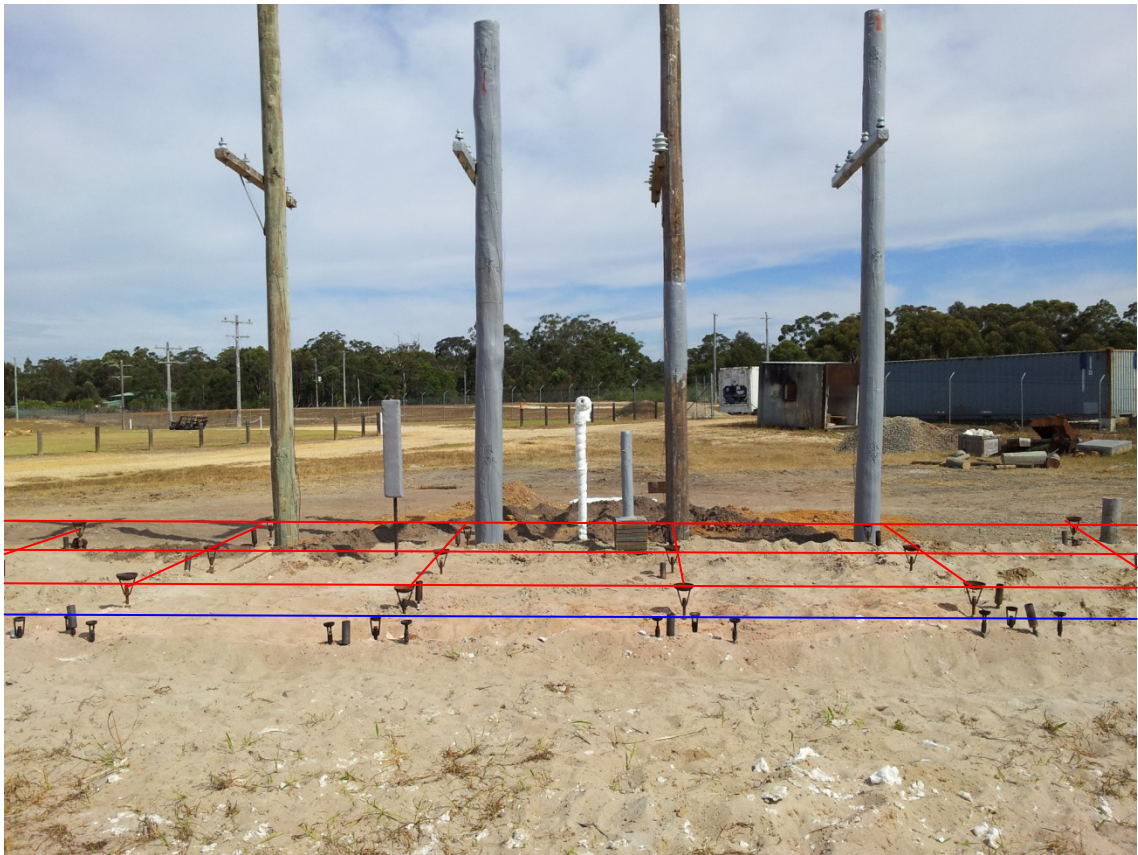
Figure 20 Grid layout

Figure 20 shows the grid layout. The clusters of burners in the foreground (shown in blue) are used to control the radiant heat applied to the face of the poles. They consist of a row of 4 groups of 3 burners positioned approximately 5 m from the front of the poles. Each of the three burners in the group has a selected jet size. By utilising a combination of the 3 burners the radiant heat on the wall can be adjusted.

The main burners consist of a grid (shown in red) of 6 by 3 burners spaced approximately 2 m and 1.5 m apart respectively. The first row of the main burners is positioned approximately 0.5 m from the front of the poles. For the flame immersion phase all the burners are turned on.

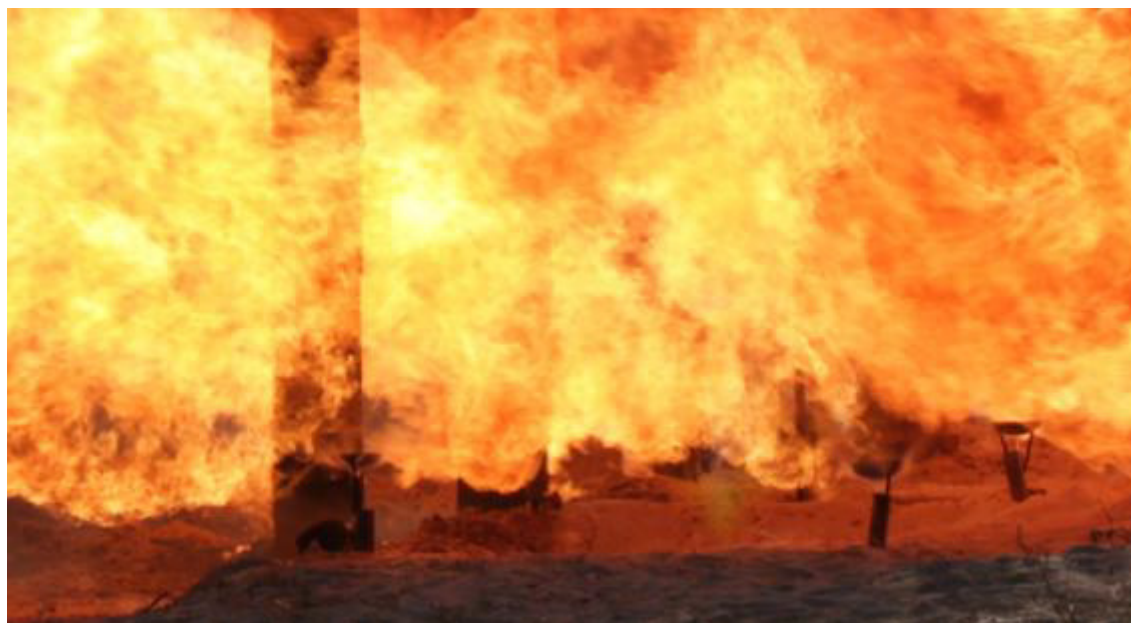
Figure 21 main grid burners at full flow

Burner nozzles used are mounted on 150 mm vertical stems off the manifolds. This allows the manifolds to be covered with sand to a depth of 50 to 100 mm for heat insulation see Figure 21. Brass jets, appropriately sized for each test, can be quickly screwed in as needed. For the purpose of flame shaping, each burner has a convex-down deflector approximately 150 mm in diameter mounted 150 mm above the jet. For this experiment the burner nozzles delivered at approximately 16 MW/m of fire line, which is the upper limit of the grid supply network.

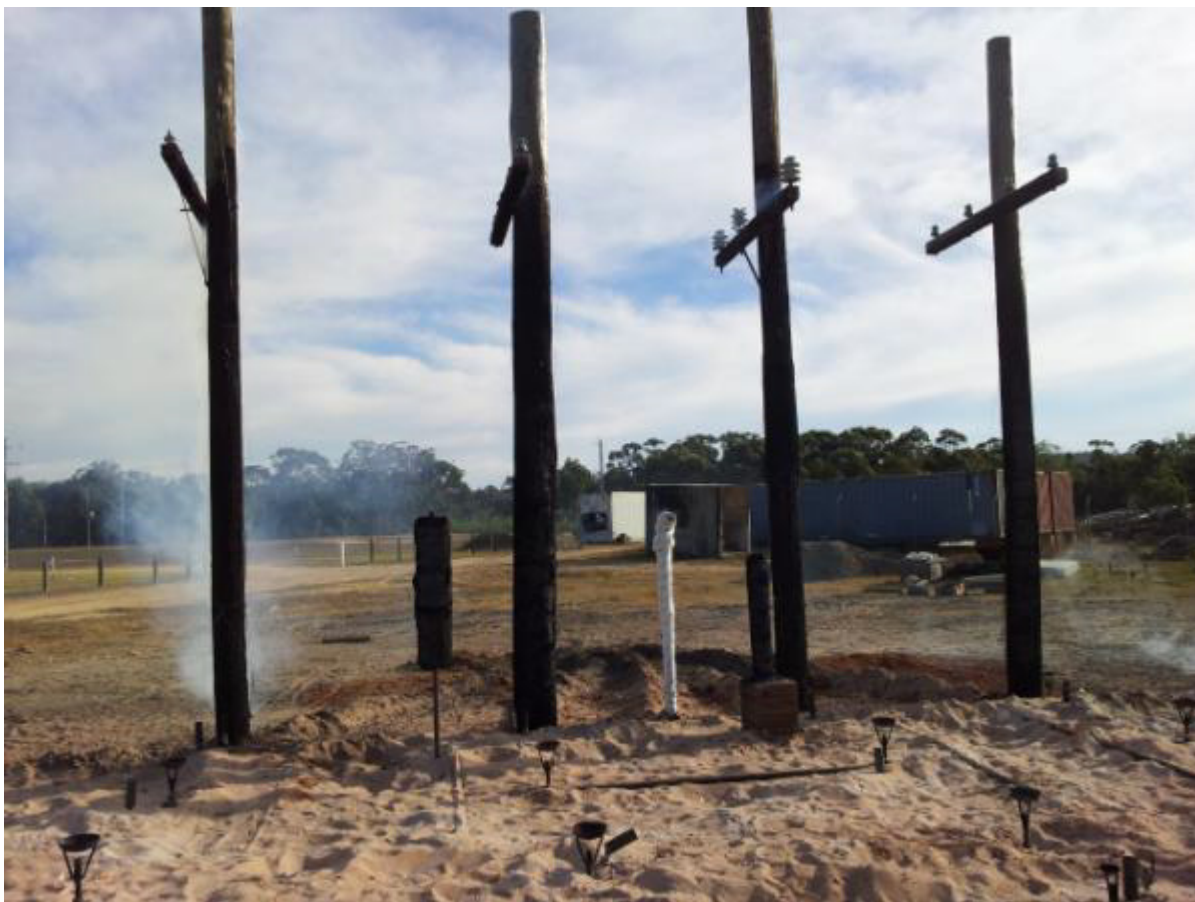
Figure 26 Poles after test note ongoing smoke emission for pole 1 on left.

- Pole 1 (treated) continued to smoulder and burn post test well into the following day at which point there was no structural timber left standing, see Figure 26.
- Combustion of pole 3 ceased shortly after radiation ceased except for a small region of pole immediately adjacent to the cross-arm where ingoing smouldering of pole and cross air continued.
- Combustion of the coated poles was not evident when the main flame immersion phase was complete

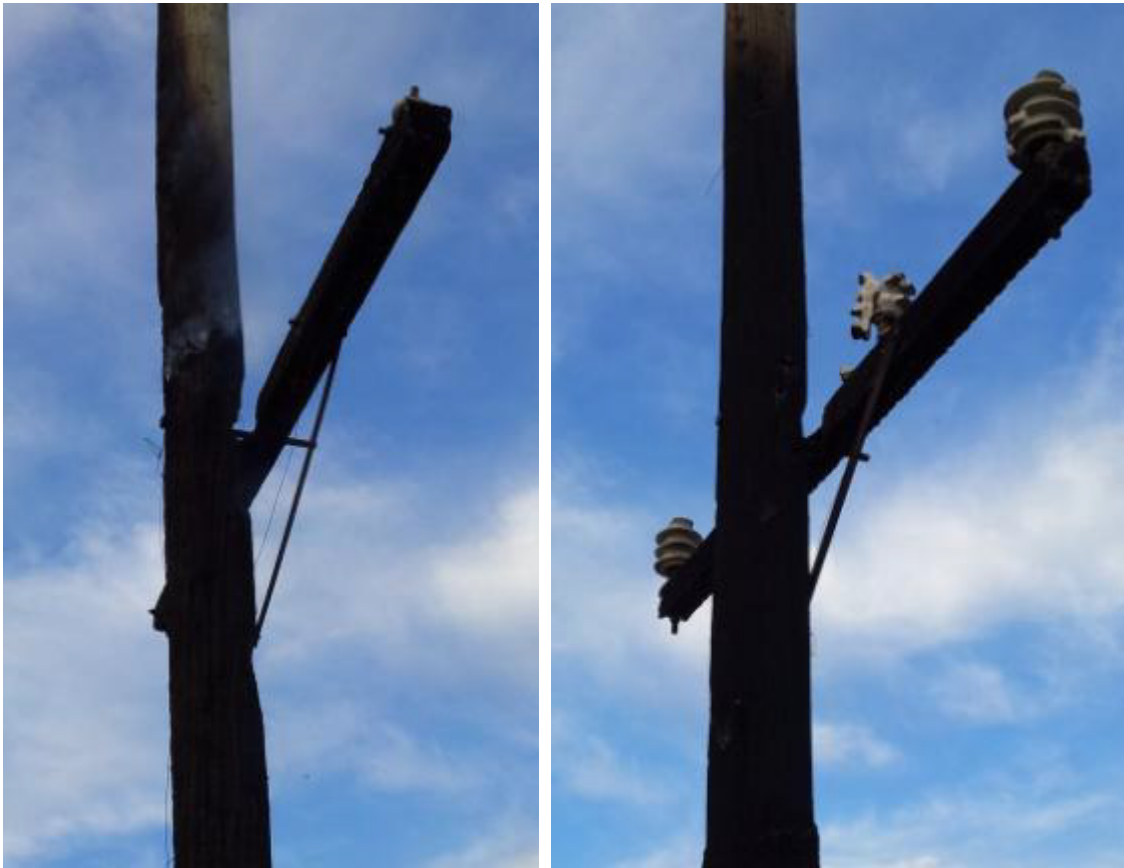
Figure 27 cross-arm smouldering at pole interface for uncoated poles, pole 1 left, pole 3 right

- The cross-arms on the uncoated poles are significantly burnt at the joint with the pole and continue to smoulder.
- The cross-arms on the coated poles had no evidence of weakening at cross-arm joint.

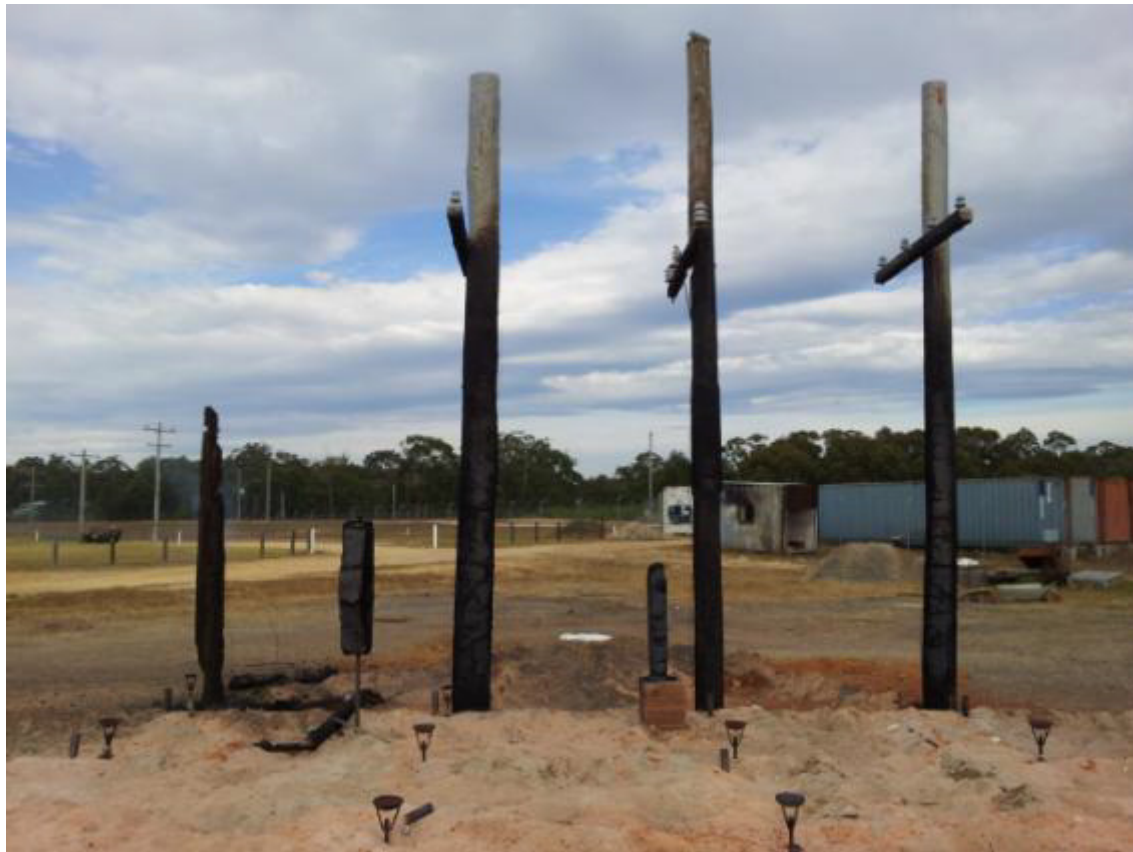
Figure 28 Poles 17 hours after the test

- Most of Pole 1 (treated) has burnt away with only the top and the base remaining. Continues to smoulder, see Figure 28 and Figure 29.
- The coated poles are in the same condition as after the test with only surface charring of the coating of the poles and cross-arms. The charring on the coated cross-arm is shown in Figure 32 showing how the pole to cross-arm interface has no significant charring.
- Pole 3 (untreated) is in a similar condition to after the test with outer surface charring except that the area around the cross-arm attachment had continued to smoulder and ceased at some stage during the night. The extent of the cross-arm damage is shown in Figure 31.
