# Bushfire Burnover Assessment of NanoChar™ Coated Powers Poles May 2013

CSIRO Ecosystem Sciences  
EP135714  
May 2013  
Commercial in Confidence

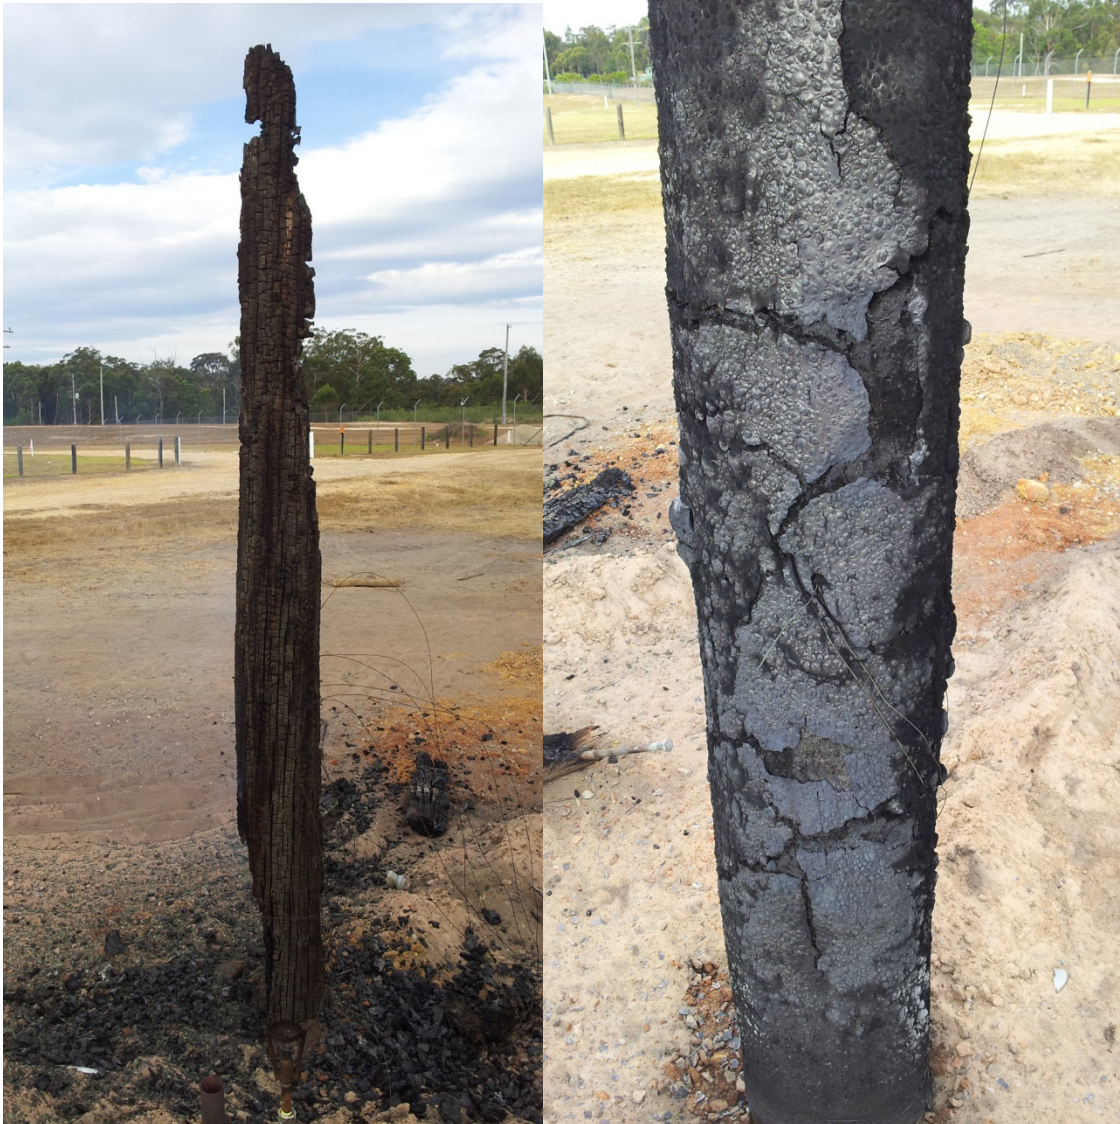
Figure 29 Pole 1 and 2 17hrs after test

- Most of Pole 1 (treated) has burnt away with only the top and the base remaining. Continues to smoulder, see Figure 28 and Figure 29.
- The coated poles are in the same condition as after the test with only surface charring of the coating of the poles and cross-arms. The charring on the coated cross-arm is shown in Figure 32 showing how the pole to cross-arm interface has no significant charring.
- Pole 3 (untreated) is in a similar condition to after the test with outer surface charring except that the area around the cross-arm attachment had continued to smoulder and ceased at some stage during the night. The extent of the cross-arm damage is shown in Figure 31.

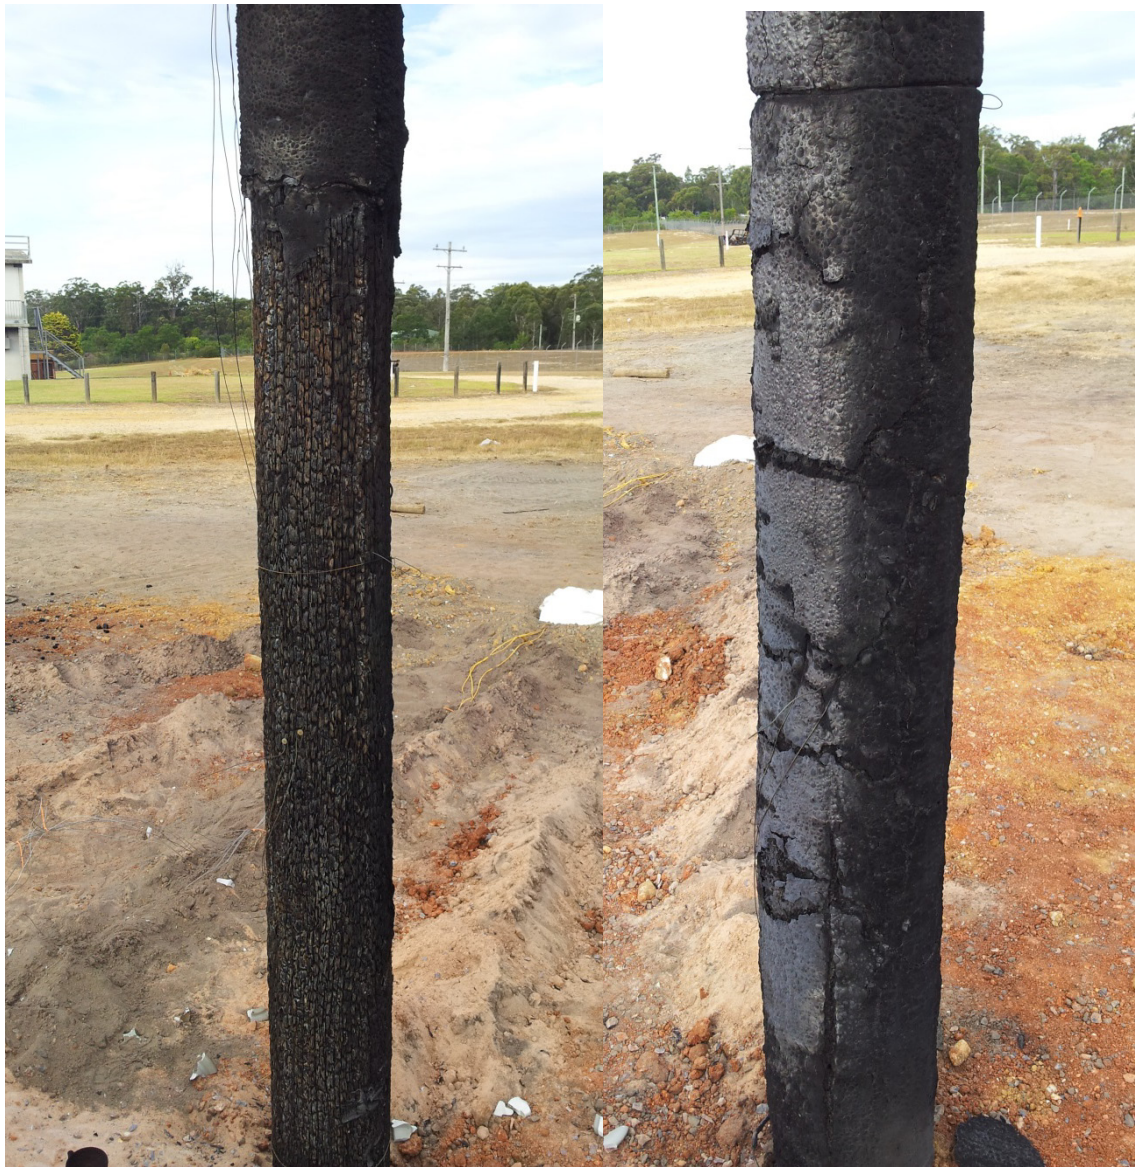
Figure 30 Pole 3 and 4 17hrs after test

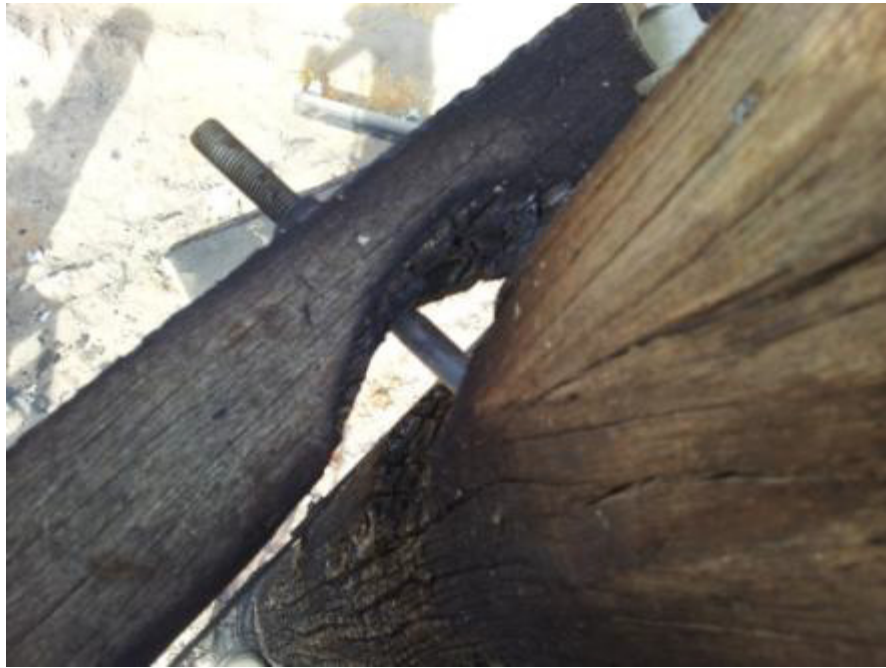
Figure 31 Cross-arm on Pole 3 (untreated) 17 hrs after test

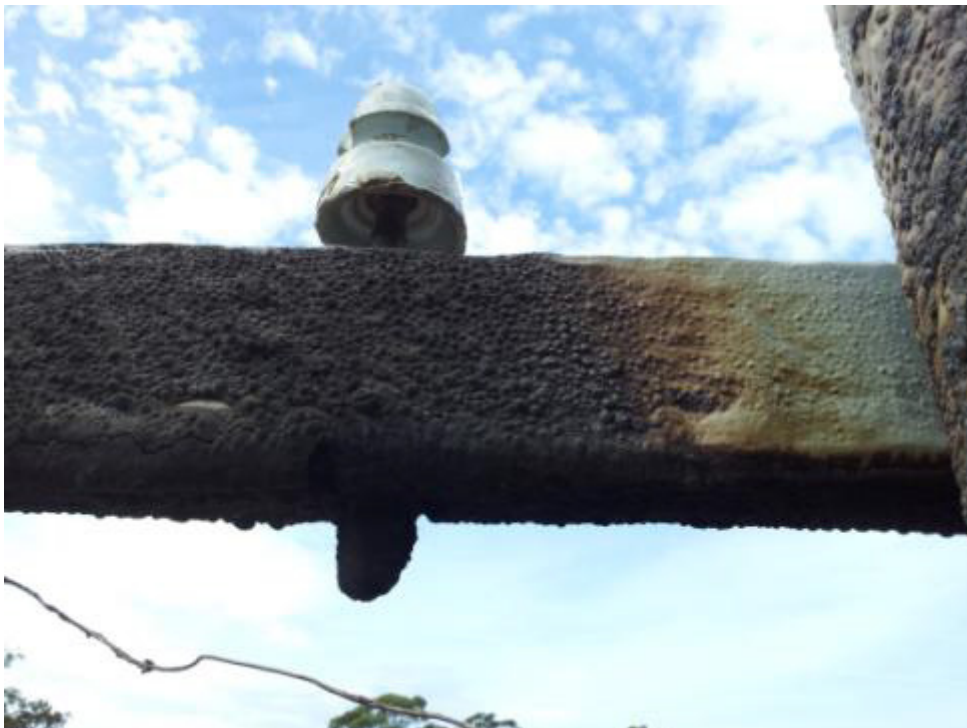
Figure 32 Coated cross-arm after the test

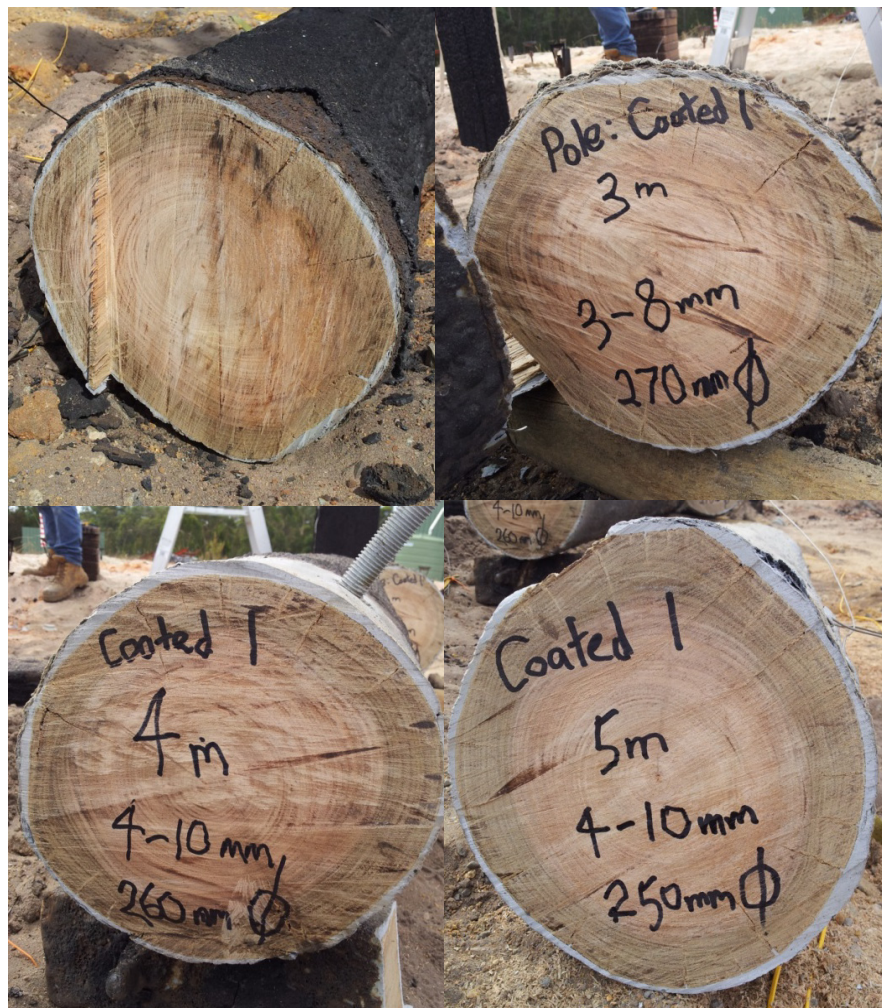
Figure 33 Cross-section through pole 2 (coated 1)

(clockwise from top left: 1m, 3m, 5m, 4m sections)

Photos of cross-sections through one of the coated poles (pole 2) are shown in Figure 33. The following points are noted:

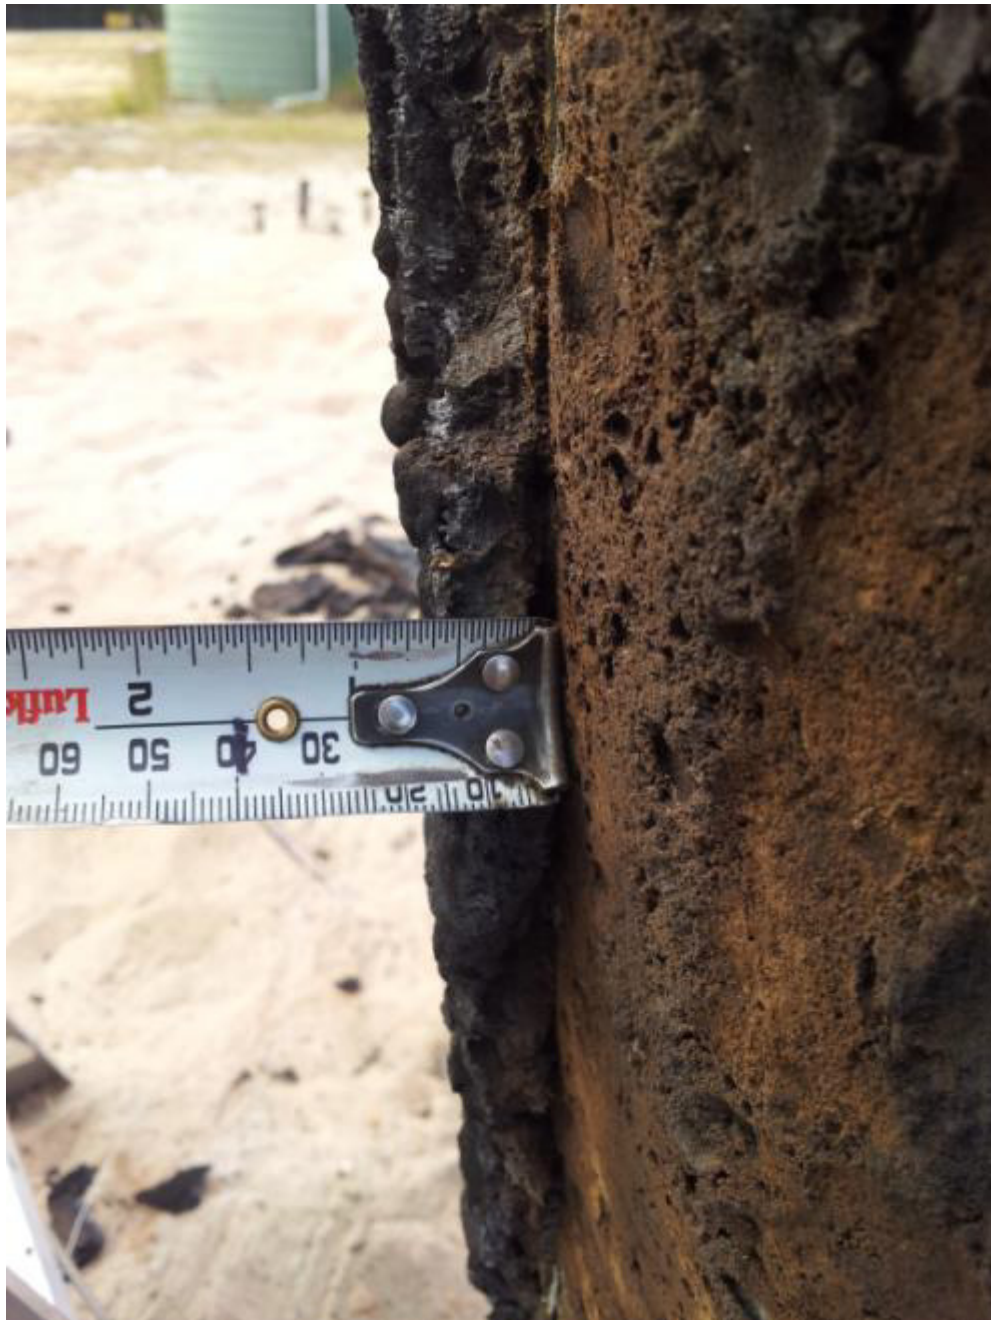
Figure 34 Char depth on coated pole at approximately 1m above the ground

- The expanded char thickness at 1m above the ground was 10-20mm thick (see Figure 34 & Figure 34). This equates to 1-2mm of converted coating.
- The pole ground interface showed not specific modes of coating failure, see Figure 35.
- Observations at 2m are similar to 1m.
- At 3m above the ground the char depth is <10mm or less than 1mm of converted coating
- At 4 m above the ground there was no significant charring.
- There is a significant minimum depth of coating remaining (between 3-8mm) on the coated poles (see Figure 35) providing enough protection for at least two more exposures of the same magnitude even if the protective char was removed prior subsequent exposures.
- The timber substrate showed no evidence of charring under the epoxy coating.

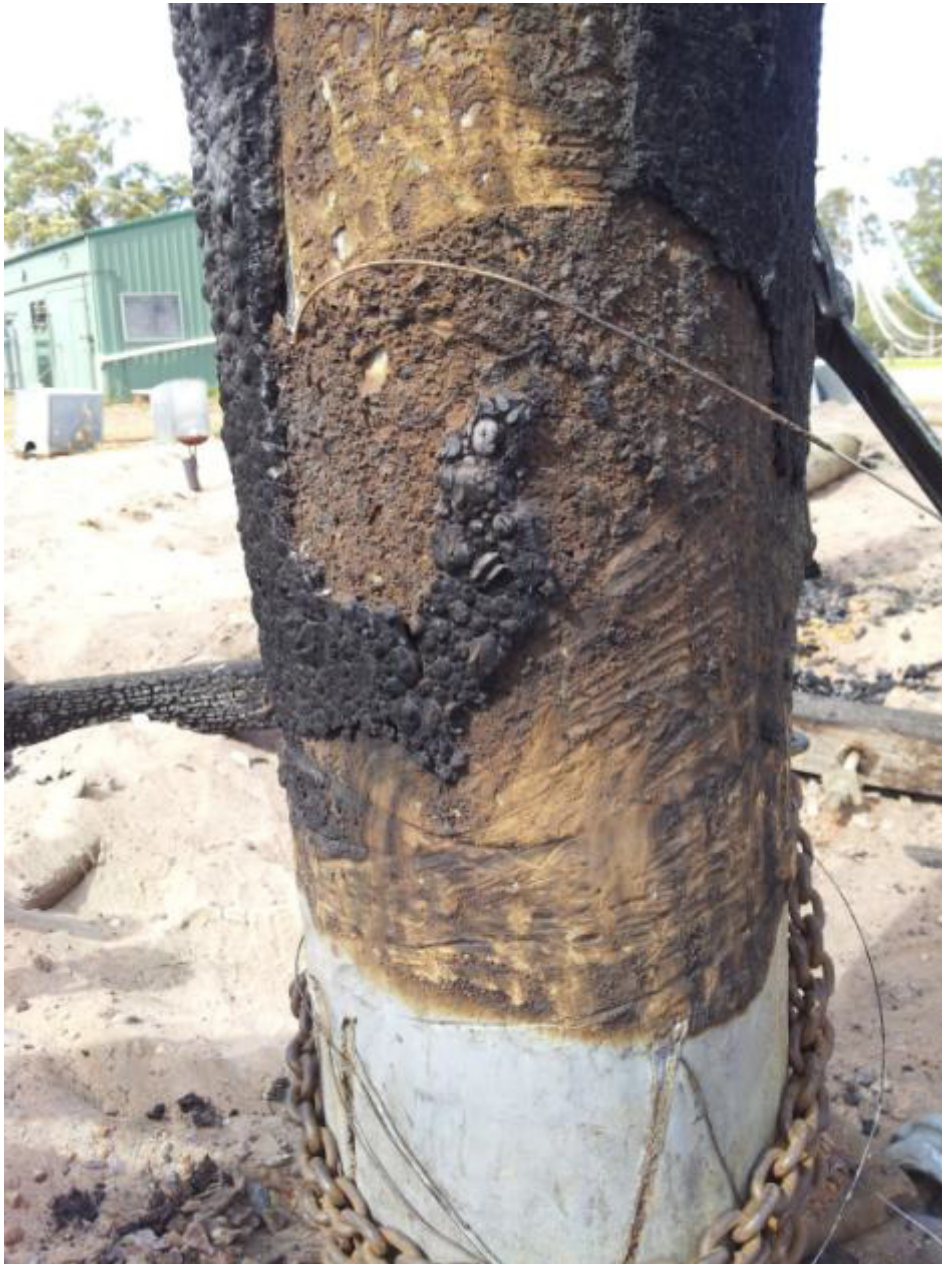
Figure 35 Coated poles being withdrawn from soil
